Comprehensive Operational Evaluation of Fairview Park Wetlands and Riparian Habitat

City of Costa Mesa
77 Fair Drive
Costa Mesa, CA 92628
Contact: Cynthia D'Agosta

DUDEK
2280 Historic Decatur, Suite 200
San Diego, CA 92106
Contact: Nicole Rieger, PE and Jennifer O'Brien, EIT

October 2020

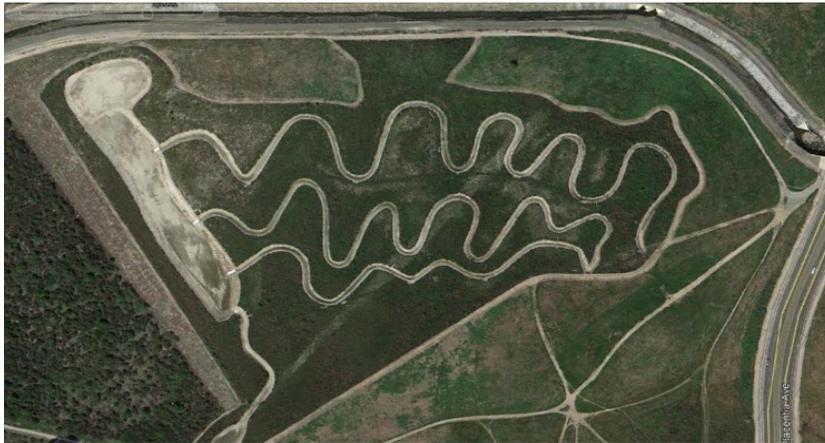
Figure 1.3: A View of the Completed Phase I of the Study Area

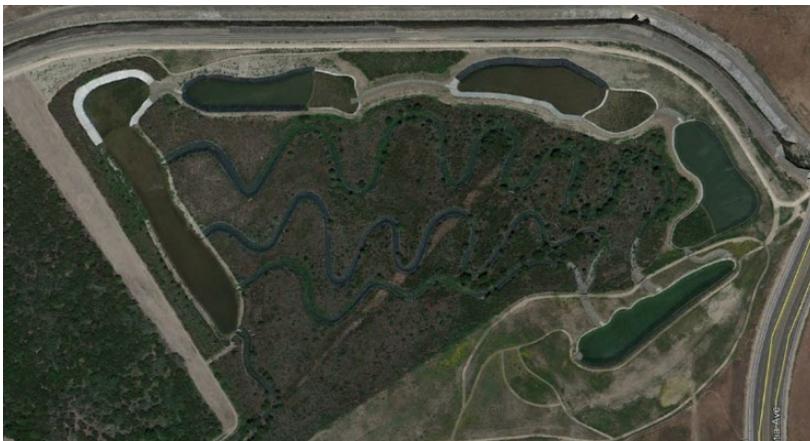
Figure 1.4: A View of the Completed Phase II of the Study Area

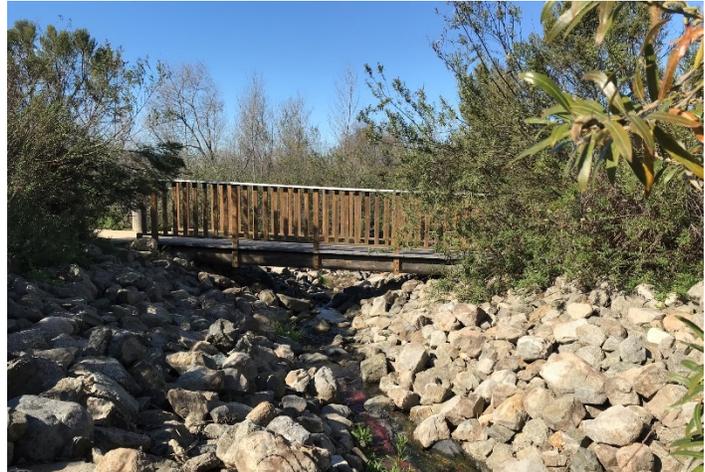
Figure 1.5: A View of a Channel from Phase I of the Channels Designed to Water the Mitigation Area

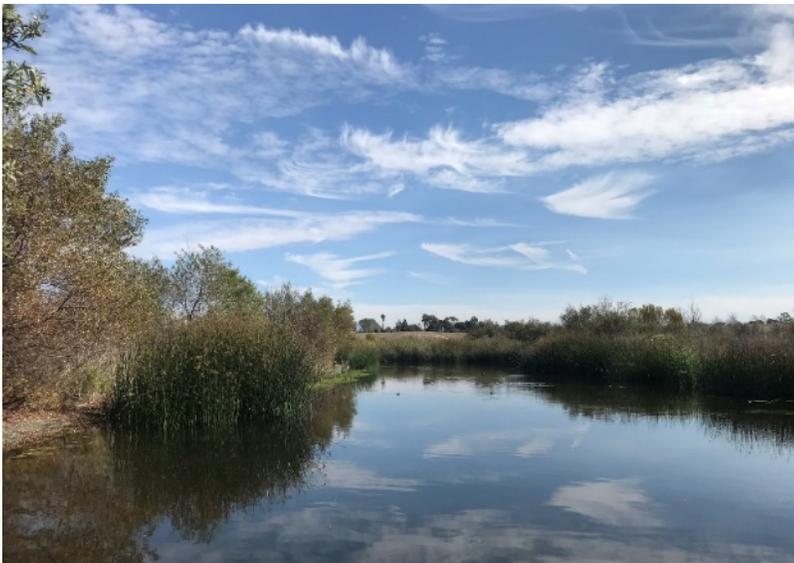
Figure 1.6: A View of a Pond from Phase 2 Constructed Wetland

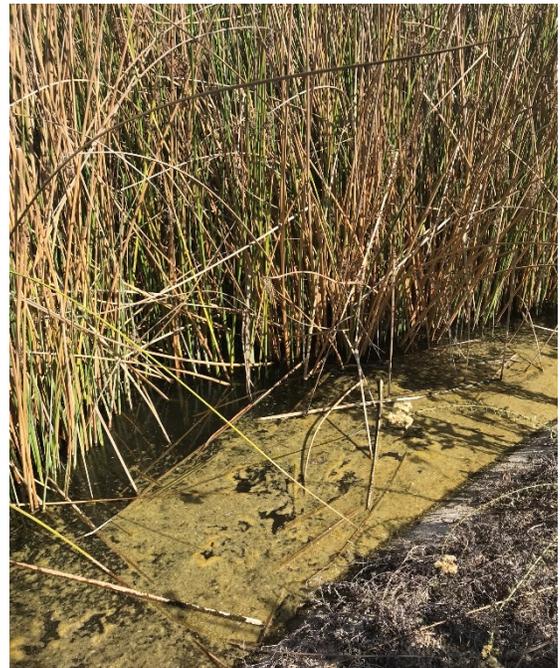
Figure 1.7: Emergent Vegetation and Stagnate Water in Shallow Areas

- a. Emergent vegetation in shallow water – Mosquitos readily breed and hatch larvae in water that is less than 2-ft deep. Larvae cannot survive to maturity in water that is greater than 1-2 feet in depth. The 2015 Vector Control Plan recommends that emergent vegetation be confined to areas where water is greater than 2-feet in depth to control mosquito populations. Currently emergent vegetation is growing in areas where water is less than 6 inches deep, as shown in Figure 1.7. Such areas are ideal for breeding of mosquitos and hosting larvae to maturity.

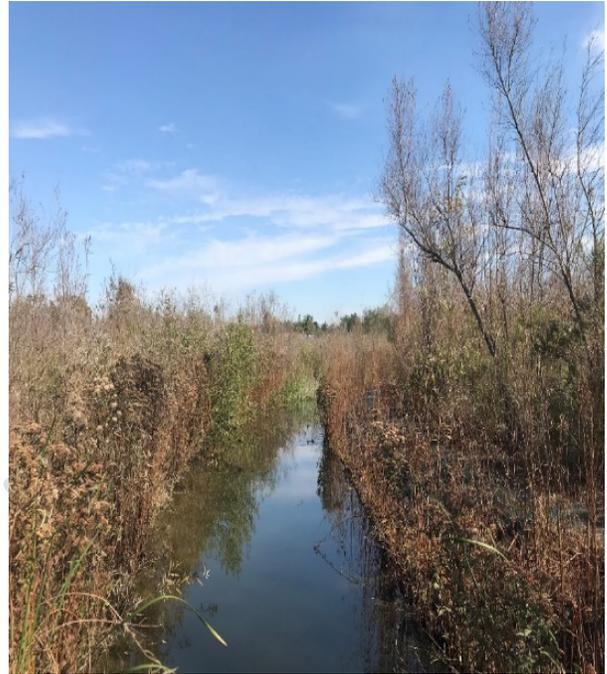
- e. Lack of dedicated pond and channel perimeter access paths – There are no dedicated maintenance paths around the ponds or wetlands as shown in Figure 1.8. The area is densely vegetated and is known to have rattlesnakes that reside in the wetland/pond area. Some pathways have been established by maintenance personnel by trampling vegetation. This does not provide stable footing and could obscure view of a snake or other hazard(s) which could lead to a maintenance worker being bitten.

Figure 1.8: Channel without Maintenance Access Provided on Either Side of the Channel or a Defined and Hardened Edge

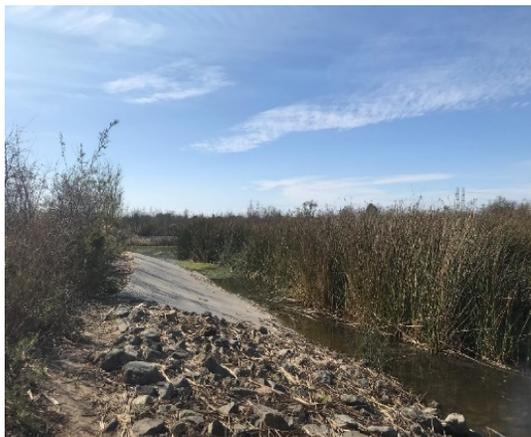
- f. Steep slopes above water surface at pond edge – In some locations the ground slope above the water surface is steep, approximately 3:1 (Horizontal: Vertical), as shown in Figure 1.9. This is not a safe slope to traverse. It may create a slip and fall hazard that could result in maintenance personnel being injured and/or falling into the pond.

Figure 1.9: Pond with 3:1 Sloped Edges, Large Clusters of Emergent Vegetation and Emergent Vegetation in Shallow Stagnate Water

- c. Large clusters of emergent vegetation - Large clusters of dense emergent vegetation provide habitat for mosquito breeding and development of larvae. The 2015 Vector Control Plan recommends that emergent vegetation be limited to clusters that are 50-75-feet in width, to allow for effective application of mosquito control spray or dispersal of mosquito control Bti pellets. Review of an April 2018 aerial image of the study area revealed emergent vegetation clusters spanning over 1,000-ft in length.

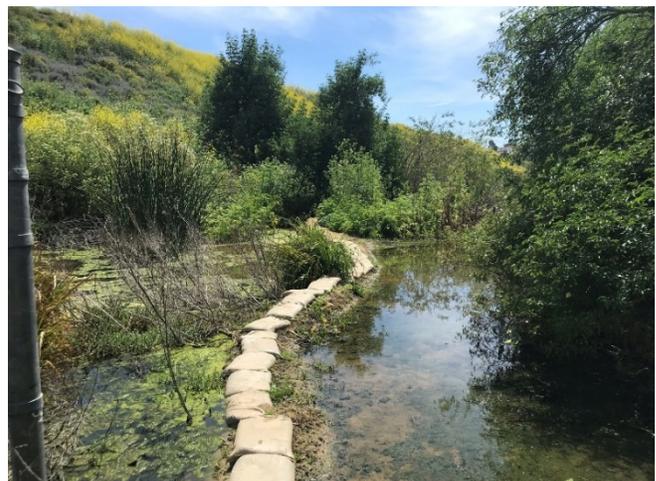
- i. Stagnant water in the Placentia Drain – During the duration of this study, stagnant water was observed in the Placentia Drain on numerous occasions and for 5 to 6 days of the week for a 3-week period from February 15, 2019 through March 6, 2019. Observation of historic aerial images dating back to March of 2015 also indicate standing water in the Placentia Drain, located outside of the study area, just downstream of the Pond-F outlet. Review of historical aerial photographs appear to indicate that a gradual eroding and failing of the bluff slope approximately 1,100 feet downstream of the Pond-F has blocked the Placentia Drain and impedes flow in the channel between the blockage and Pond-F. There are no water quality provisions to maintain water quality in the Placentia Drain impoundment area. It is not known if OCVCD routinely applies vector control measures to this portion of the drain. The stagnant water in the Placentia Drain is less than 0.5 mile from the residential homes on Swan Drive. This water also has extensive seasonal filamentous algae growth and emergent vegetation as seen in Figure 1.10. Stagnant untreated water less than 2-ft deep, with algae blooms, and emergent vegetation, standing for more than 48-hours provides suitable habitat for mosquito breeding and larvae development. See *Exhibit 3* to view a map of the offsite water features including the Placentia Drain.

Figure 1.10: Ideal Mosquito Breeding Grounds in the Placentia Drain

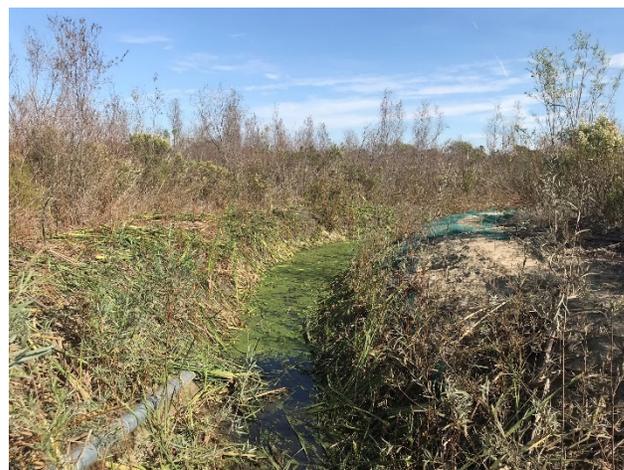
- e. Temporarily blocked transfer weirs between ponds and channels – For the duration of this study, some of the transfer weirs between the ponds and channels were temporarily partially blocked by items moved by trespassers (rocks, sandbags, tree branches, etc.) requiring daily monitoring . The partial blockages are contributing to the low water conditions and poor water quality in the channels and contributing to the creation of favorable mosquito habitat.

All weirs and channels appeared to be in good structural condition and in some locations, sedimentation occurred obstructing flows through the weirs and channels.

During the desktop study described in Section 2.1, Dudek observed that the design team for the study area had sized the channels and weirs to have the ability to convey large amounts of runoff that could come during large storms where water might run onto the study area from surrounding areas including the adjacent canyon that is also part of Fairview Park. This is common practice for stormwater engineering. Due to the channels and weirs being designed for large storm events, observed normal depths of water for the system are shallow and slow. Shallow and slow water creates ideal conditions for mosquitos, algae and plant growth.

Figure 3.1: Channel 2 with stagnate water blocked by sand bags.

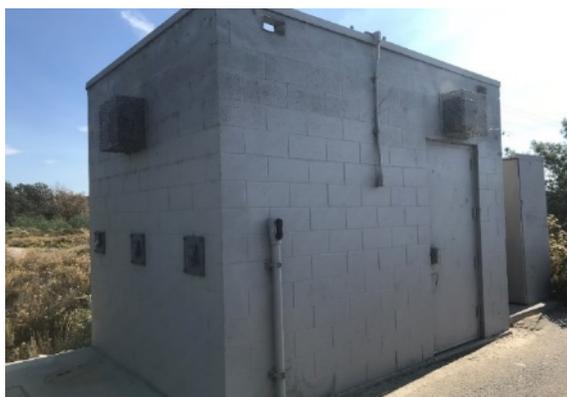
Figure 3.2: Exterior of Pump Station

The existing GBC water quality pump station was visually inspected on March 12, 2019 with City employees and Orange County Pump Station Operator, Marvin Moscoso. Observations from the pump station inspection were generally broken down into three categories: Site, Mechanical, and Electrical/Instrumentation. The observations from the pump station inspection included: mechanical components including piping and valves; electrical/instrumentation components including the control system, salinity probe; and ability to monitor of the pump station systems.

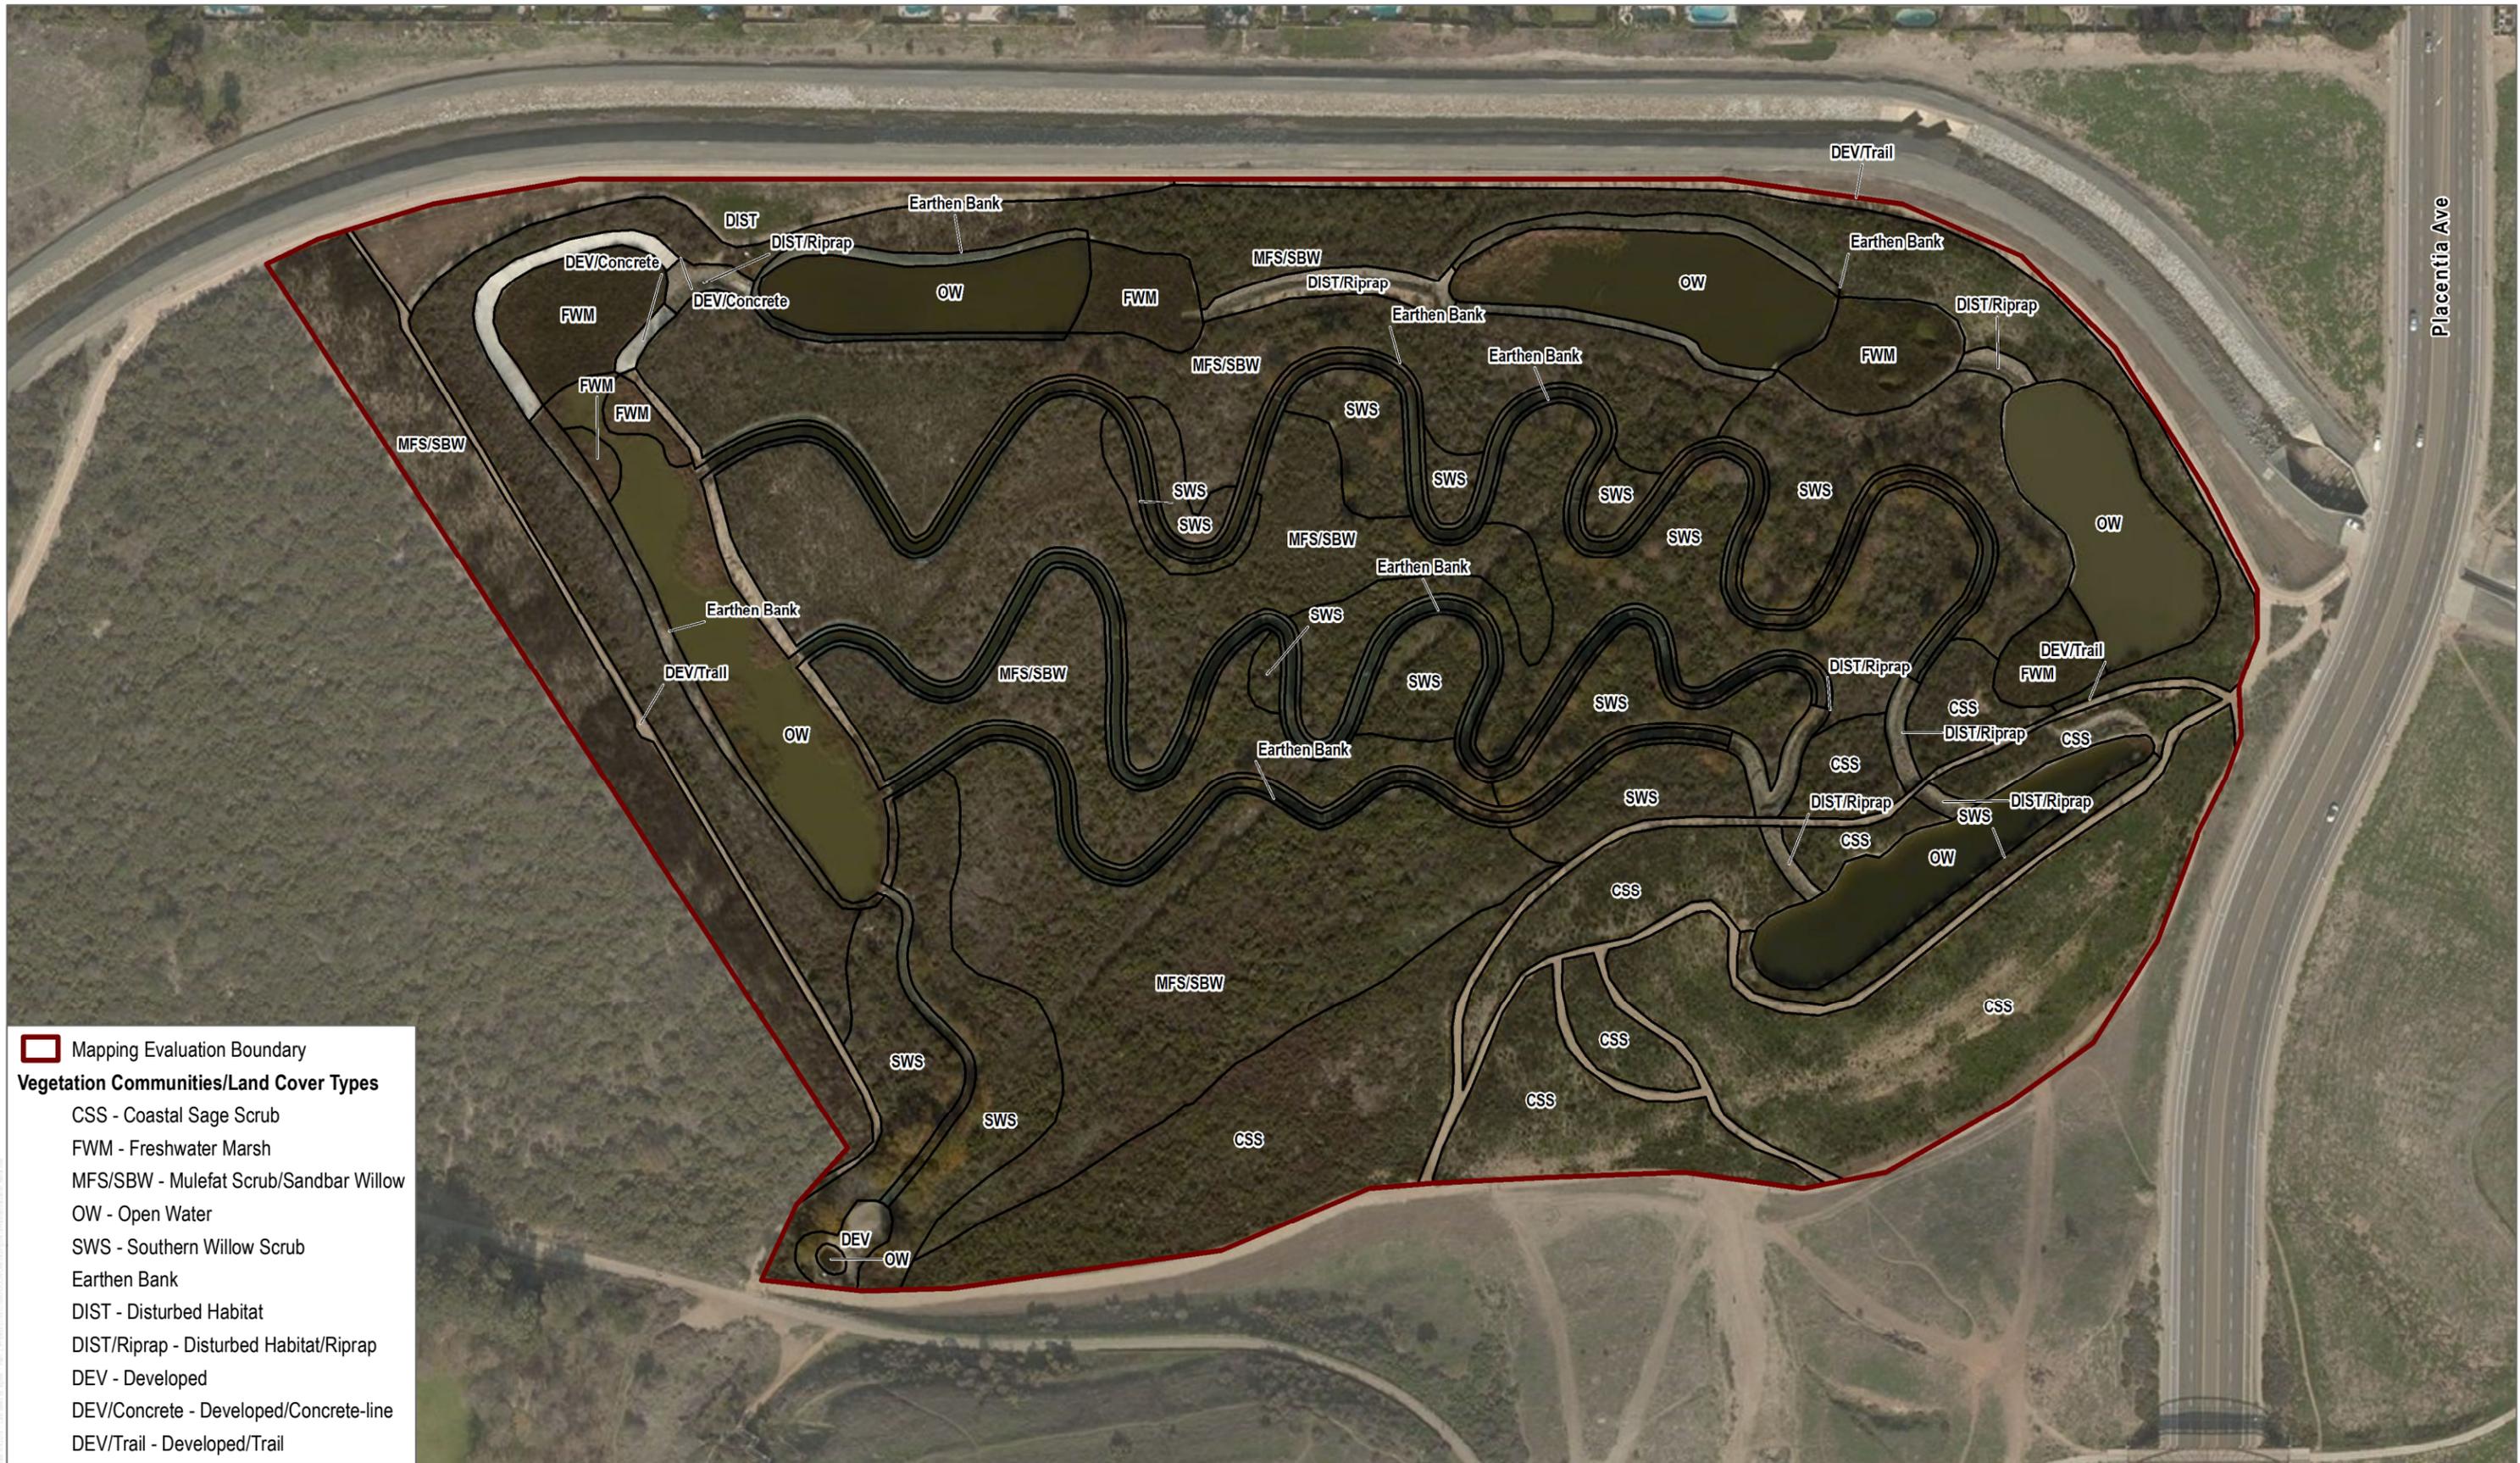
- Mapping Evaluation Boundary
- Vegetation Communities/Land Cover Types**
- CSS - Coastal Sage Scrub
- FWM - Freshwater Marsh
- MFS/SBW - Mulefat Scrub/Sandbar Willow
- OW - Open Water
- SWS - Southern Willow Scrub
- Earthen Bank
- DIST - Disturbed Habitat
- DIST/Riprap - Disturbed Habitat/Riprap
- DEV - Developed
- DEV/Concrete - Developed/Concrete-line
- DEV/Trail - Developed/Trail

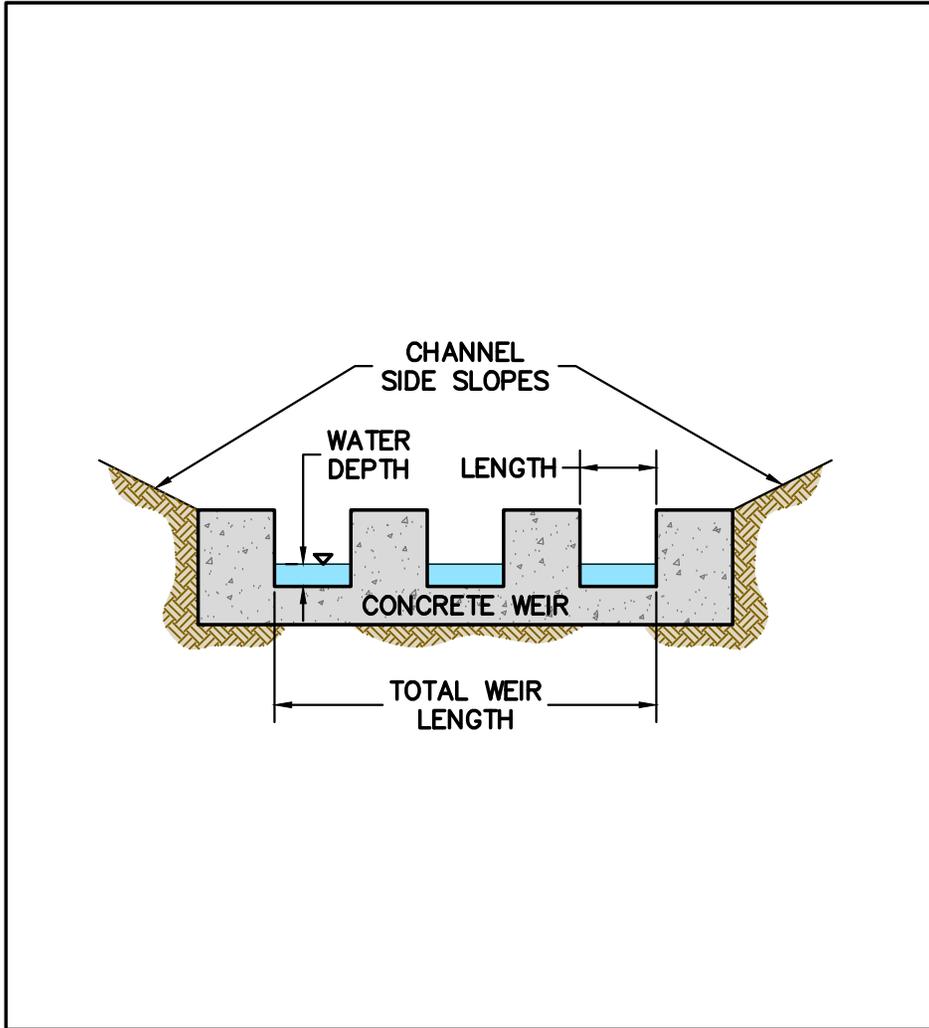
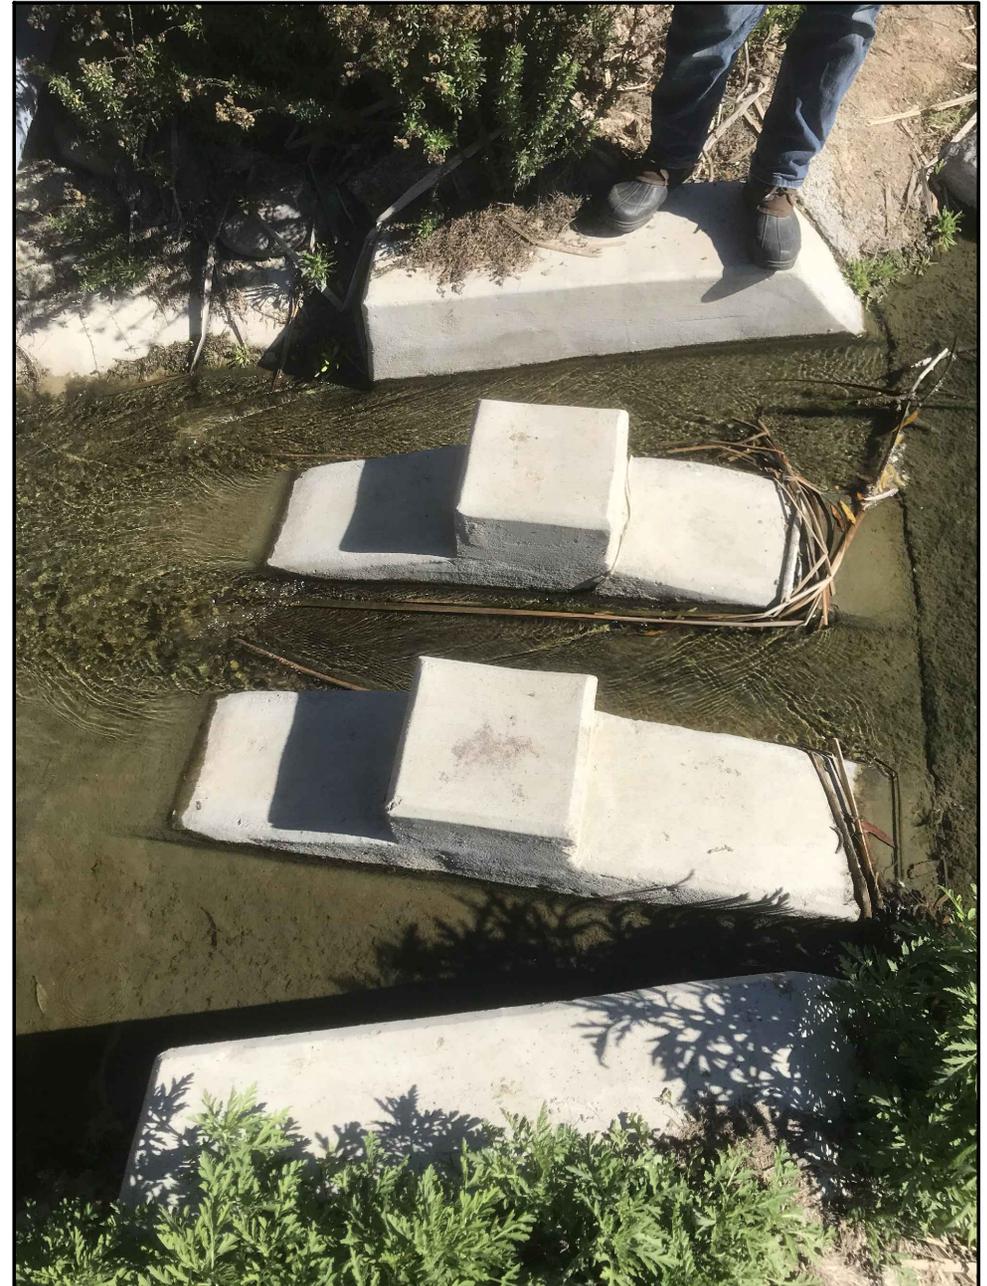
TYPICAL SECTION OF WEIRS IN FAIRVIEW PARK

EXAMPLE PICTURE OF WEIRS IN FAIRVIEW PARK
